VISUAL SITE INSPECTION REPORT – 2018

SOUTHERN INDIANA GAS AND ELECTRIC
A. B. BROWN GENERATING STATION
TYPE III RESTRICTED WASTE LANDFILL
WEST FRANKLIN, IN

ATC PROJECT NO. 170LF00614

January 9, 2019

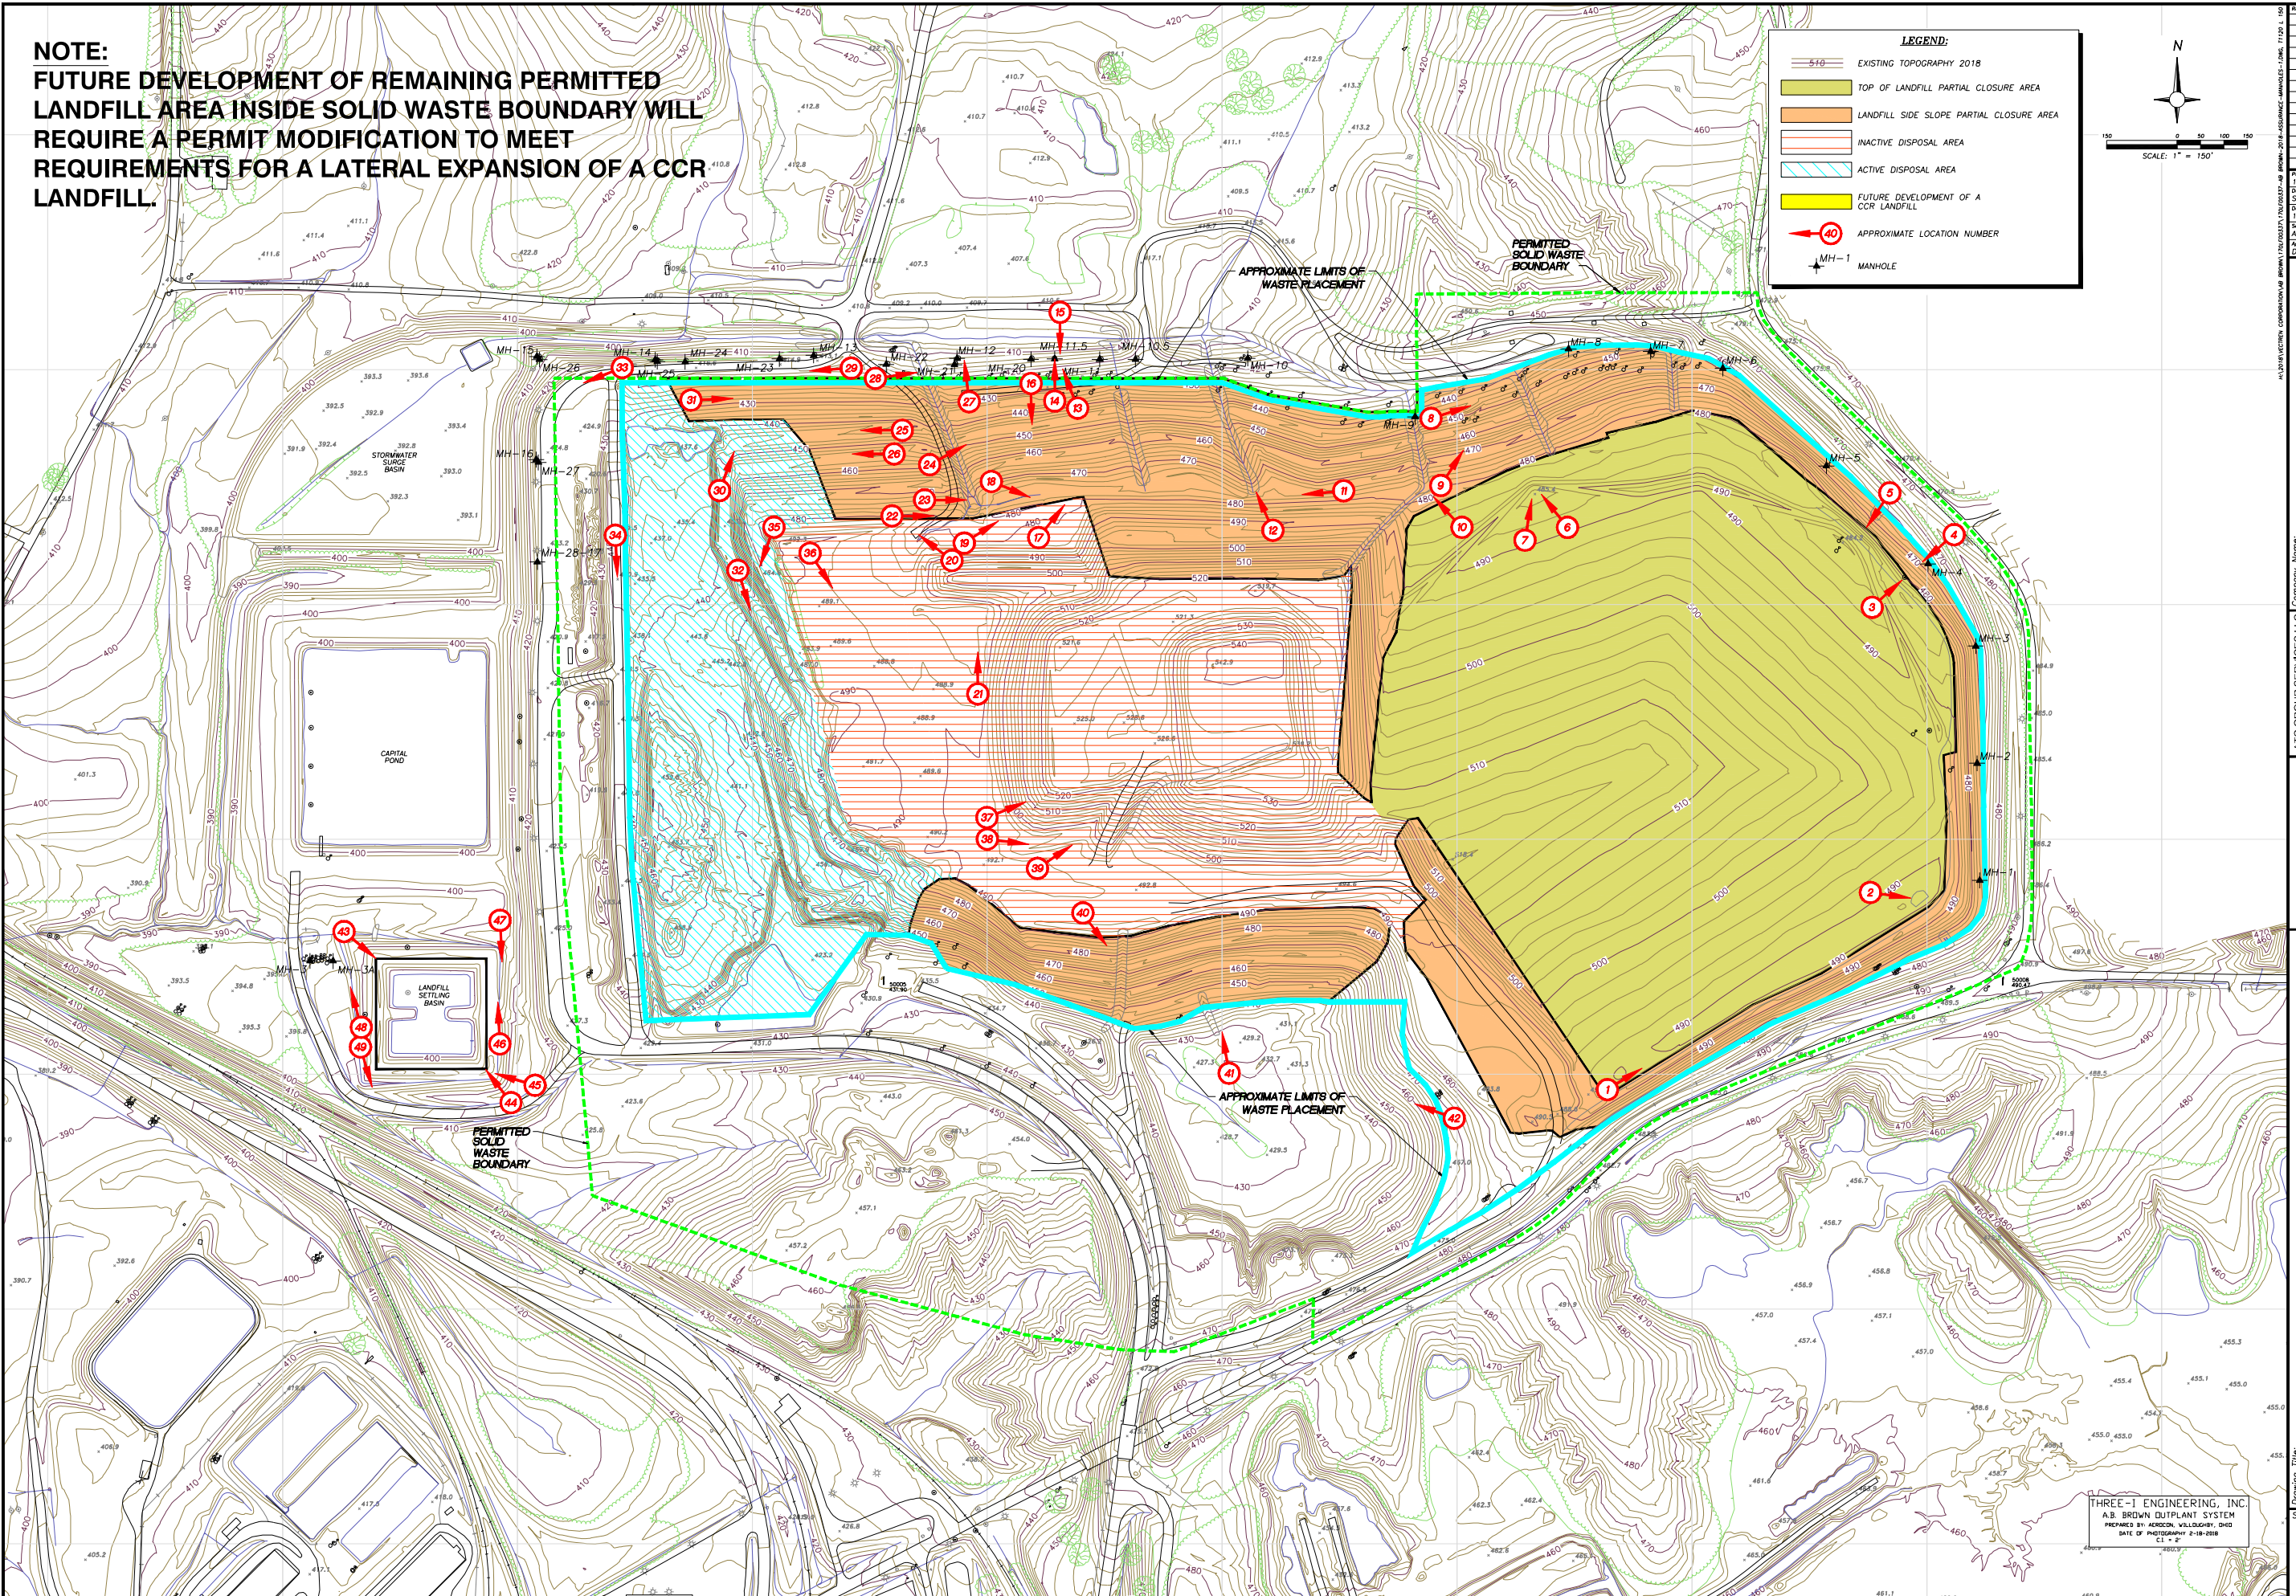
Sheet:
1

- 1) In general, this area is well vegetated and well maintained (Locations 1, 2, 9, 11, and 31). No concerns exist at this time.

- 2) The inlet to a drainage culvert on the east side of the landfill has been blocked by riprap (Location 3). Additionally, the inspection noted minor erosion at the outlet of the same culvert (Location 4).

- 3) A sinkhole has developed above a culvert outlet on the east slope of the Partial Closure Area indicating a joint failure (Location 5). Additionally, the inspection noted erosion along perimeter of outlet splash pad.

- 4) On the north side of the Top of the Landfill Partial Closure Area, two (2) drop inlets have become clogged with vegetation debris (Locations 6 and 7).

- 5) A seep is present on the north slope near the east end of the landfill. A trench has been excavated in the area to collect the seep water and convey it in pipes to the Capital Pond. It is our understanding that the flow rate varies seasonally and that the peak rate continues to decrease following the construction of the composite final cover across the top of the east end of the landfill (Location 8).

- 6) On the north slope of the Landfill Partial Closure Area, several of the riprap channels have become overgrown with vegetation along edges of the stone reducing the flow into the channels (Location 10).

- 7) On the north slope of the Landfill Partial Closure Area, flow from the outlet of a down-drain culvert is causing erosion and undercutting at the opening of a riprap channel (Location 12).

- 8) On the north slope of the Landfill Partial Closure Area, an HDPE pipe has been installed from the active fill operations in the Vertical Expansion Area to Manhole #11.5 (Locations 13, 15, 16, 21, and 28). At the time of the inspection, there were no erosion or sediment controls installed upstream of the pipe inlet (Locations 17 and 18) allowing filter cake sediment to flow directly into the pipe and into the stormwater management system outside of the Solid Waste Boundary. As a result, Manhole #11.5 accumulated a significant volume of sediment (Location 14). Based on the presence of filter cake sediment on the outside of Manhole 11.5 and erosion at the base of Manhole 11.5, it also appears that the manhole recently overtopped allowing filter cake to discharge to the perimeter ditch (Location 13). At the time of this inspection, there was no evidence to indicate migration of waste beyond the property boundary.

- 9) A sediment control pond surrounded by silt fence was constructed to the west of the inlet to the HDPE pipe discussed in Item 8 (Location 18). It appears that the sediment pond was recently overtopped leaving the fence in poor condition and allowing filter cake to flow west as indicated by filter cake in the grass (Location 19). The filter cake flowed west until it reached a culvert under a roadway that was partially clogged with vegetation (Location 20). The culvert flows under the roadway and outlets on the north slope of the Landfill Partial Closure Area (Location 22) causing erosion of the roadside drainage channel. The filter cake also appears to have migrated to the culvert outlet/riprap channel at Location 23. The flow through the culvert to the north slope of the Landfill Partial Closure Area creates another path for filter cake to migrate outside the Solid Waste Boundary. At the time of this inspection, there was no evidence to indicate migration of waste beyond the property boundary.

- 10) The inspection noted water ponded in the toe of a diversion berm on the north slope of the Landfill Partial Closure Area (Location 24).

- 11) The inspection noted erosion in the toe of several diversion berms on the north slope of the Landfill Partial Closure Area (Locations 25 and 26).

- 12) The inspection noted seepage around Manhole #12 (Locations 27). Previous inspections have determined that seepage from a manhole may indicate a blockage in the drainage system.

- 13) The inspection noted recent reseeding in the perimeter ditch north of Manhole #12 (Location 28). The inspection also noted filter cake in a drainage ditch adjacent to a road outside of the Solid Waste Boundary (Location 29). Further discussions with site personnel indicated that recent heavy rains had caused sediment transport of the filter cake into the stormwater management system requiring clean up to remove filter cake, and reseeding of the perimeter ditches. At the time of this inspection, there was no evidence to indicate migration of waste beyond the property boundary.

- 14) The top of a slope of the north side of the Active Landfill Area has been graded to flow onto a diversion berm on the north side of the Landfill Partial Closure Area (Location 30) creating another path for filter cake to migrate outside the Solid Waste Boundary.

- 1) The inspection noted a steep cut-slope with a road at the top of the slope on the south end of the east side of the Active Landfill Area (Location 32).

- 2) At the northwest corner of Cell 18 at the edge of the haul road, the standing water surface in the cell is only slightly below road elevation indicating a small amount of freeboard (Location 33). During large magnitude storm events the cell may become more susceptible to overtopping.

- 2) Water is ponding at the toe of the filter cake slopes (Locations 21 and 38). It appears that water ponded at the toe of the south slope of the Vertical Expansion Area is pumped into a box culvert (Location 39) that discharges into a riprap channel (Location 40) that flows into a sediment pond at the toe of the slope within the Solid Waste Boundary.

- 1) The slopes of the Settling Basin are lined with riprap and appeared in satisfactory condition. Also, the pond is maintaining adequate freeboard (Location 43).

- 2) The southeast portion of the pond has accumulated a large volume of sediment that may impair the discharge into the pond (Location 44).

- 3) During the inspection, new piping was being installed in the southeast corner of the pond (Location 45). The intent of the new piping is to improve drainage and to prevent the accumulation of sediment in the perimeter drainage channel (Location 46).

- 4) The inspection noted erosion in the perimeter drainage channels near the northeast corner of the pond (Location 47) and along the west side of the pond (Location 48).

- 5) The inspection noted that the area around the southeast corner of the pond is not graded to drain and is ponding water (Location 49).

Recommendation: Remove riprap as needed to allow water to flow into the culvert on the upstream side of the culvert and add riprap to the downstream side to control erosion.

Recommendation: Excavate the culvert to expose the failed joint. If the joint connection appears to be intact, reset the joint and add an Agri Drain Pipe Strap, or an equivalent. If the joint or the pipe segment has been damaged beyond repair, replace the pipe segment and add an Agri Drain Pipe Strap, or an equivalent, to reinforce the joint. Also, remove the eroded soil from the perimeter of the splash pad and add additional riprap to prevent future erosion.

Recommendation: Remove grass clippings and vegetation debris to restore the original condition.

Recommendation: Trim vegetation at the edges of channels at regular intervals to maintain open flow conditions.

Recommendation: Add riprap to the outlet of the culvert to reduce the flow velocity and monitor the opening of the channel for further erosion.

Recommendation: Add sufficient erosion and sediment controls upstream of the pipe inlet to prevent filter cake from migrating outside the Solid Waste Boundary. Alternatively, reroute stormwater flows to the west into the Active Landfill Area.

Recommendation: Repair and maintain the silt fence in good condition, increase and maintain freeboard in the sediment control pond to prevent overtopping, and install additional erosion and sediment controls downstream of the pond to prevent filter cake from migrating outside the Solid Waste Boundary. Alternatively, reroute stormwater flows into the Active Landfill Area. Additionally, trim the vegetation at the culvert inlet at regular intervals to maintain open flow conditions.

Recommendation: Add soil to the diversion berm and revegetate the area as necessary to maintain flow into the drainage structures.

Recommendation: Restore the diversion berms as necessary and improve the armoring at the flow lines to prevent erosion.

Recommendation: Continue a regular maintenance program of the toe drain lines to minimize the potential for development of blockages.

Recommendation: Remove filter cake from drainage features and improve erosion and sediment controls within active placement areas in the Vertical Expansion Area to prevent migration of filter cake outside of the Solid Waste Boundary and continue proactive maintenance of stormwater controls.

Recommendation: Add sufficient erosion and sediment controls inlet to the diversion berm to prevent filter cake from migrating outside the Solid Waste Boundary. Alternatively, reroute stormwater flows to the west into the Active Landfill Area.

Recommendation: Immediately prohibit use of the road at the top of slope and regrade the area to re-establish safe slopes within the Active Landfill Area. Consider adding traffic control berms to the outside edge of roads at the top of a slope.

Recommendation: Maintain a low normal pool elevation inside the cell collection area and continue to monitor elevation rise during storm events. Consider additional drainage from inside the cell or the addition of a soil berm to increase freeboard in this area.

Recommendation: Continue to minimize ponded water within the active fill areas.

Recommendation: Remove accumulated sediments to maintain the pond capacity. The owner has reported that this action was completed following the site inspection.

Recommendation: Continue with the installation and monitor the system's performance. The owner has reported that this action was completed following the site inspection.

Recommendation: Restore the perimeter drainage channels as necessary and improve the armoring at the flow lines to prevent erosion.

Recommendation: Regrade the area as necessary to maintain drainage.
