October 13, 2016

CCR Certification:  
Initial Structural Stability  
Assessment  
§257.73 (d)

Ash Pond

A.B. Brown Generating Station

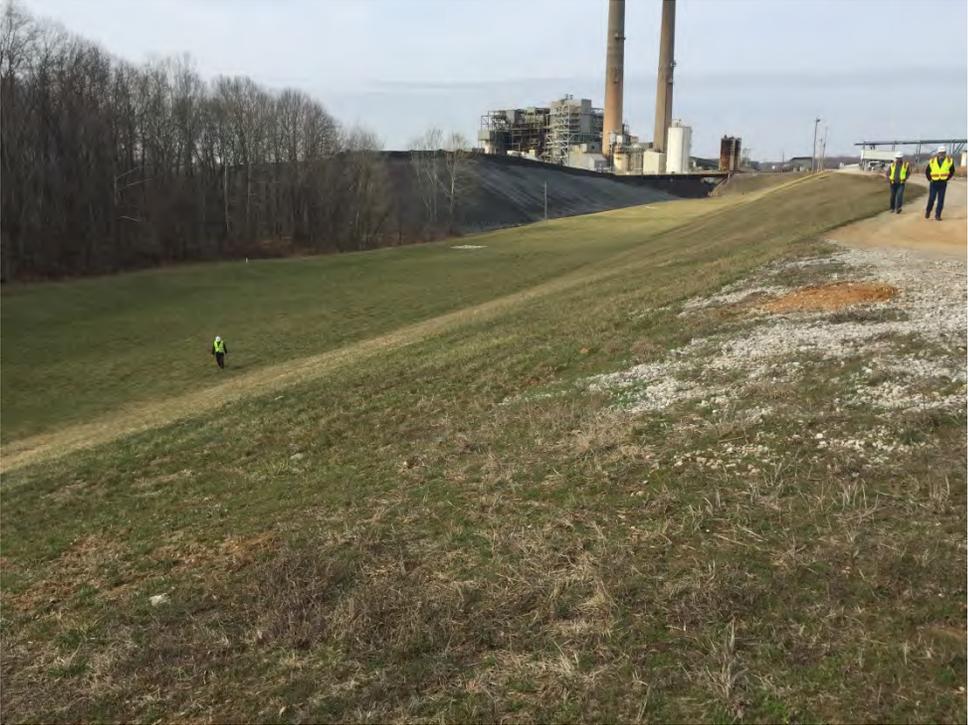
<p>Photo No. 1</p>	<p>Date: 02/23/2016</p>

<p>Location: A.B. Brown Generating Station</p>		
<p>Description:          Standing at east end of berm, looking west.</p> <p>Picture shows slope protection on downslope of berm.</p> <p>Photographer: Entwistle</p>		
<p>Photo No. 2</p>	<p>Date: 11/04/2015</p>

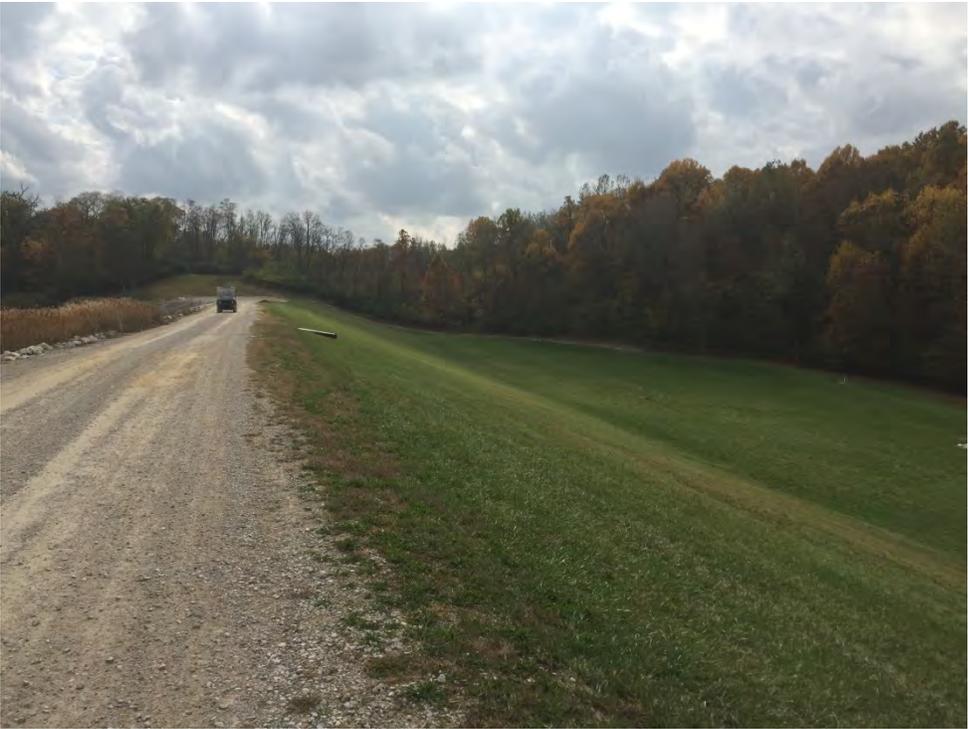
<p>Location: A.B. Brown Generating Station</p>		
<p>Description:          Standing at west end of berm, looking east.</p> <p>Picture shows slope protection on downslope of berm.</p> <p>Photographer: Entwistle</p>

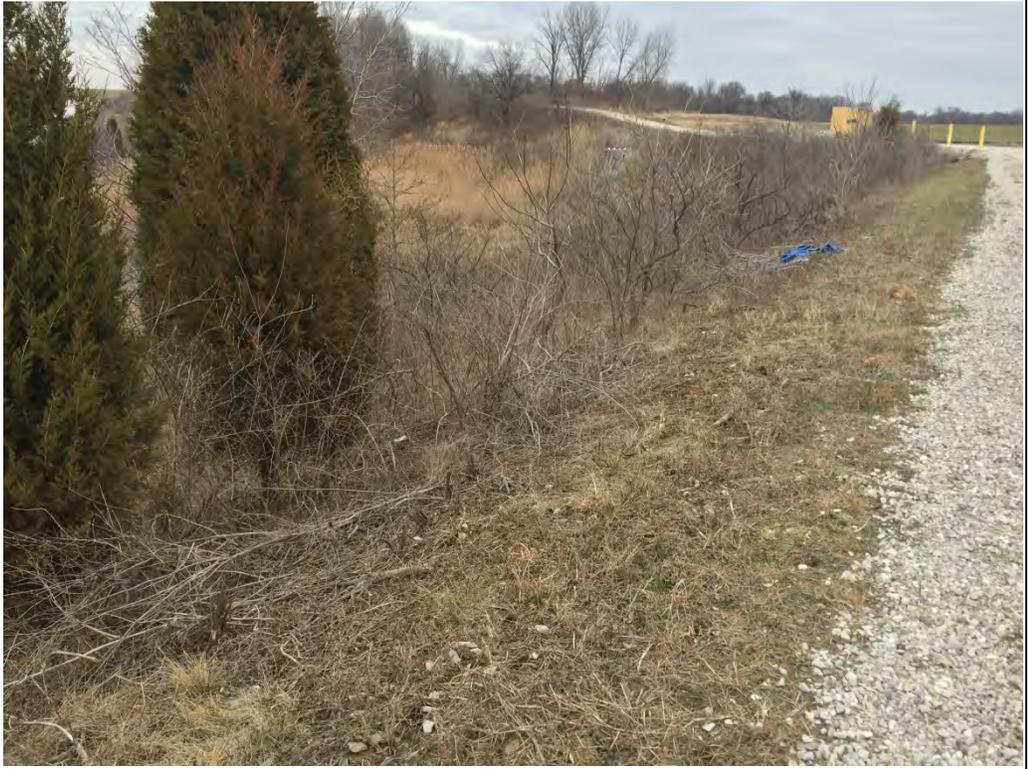
<p>Photo No. 3</p>	<p>Date: 02/23/2016</p>

<p>Location: A.B. Brown Generating Station</p>		
<p>Description:          Standing on western leg of berm, looking north.</p> <p>Picture shows slope protection on exterior face of berm.</p> <p>Photographer: Entwistle</p>		
<p>Photo No. 4</p>	<p>Date: 11/04/2015</p>

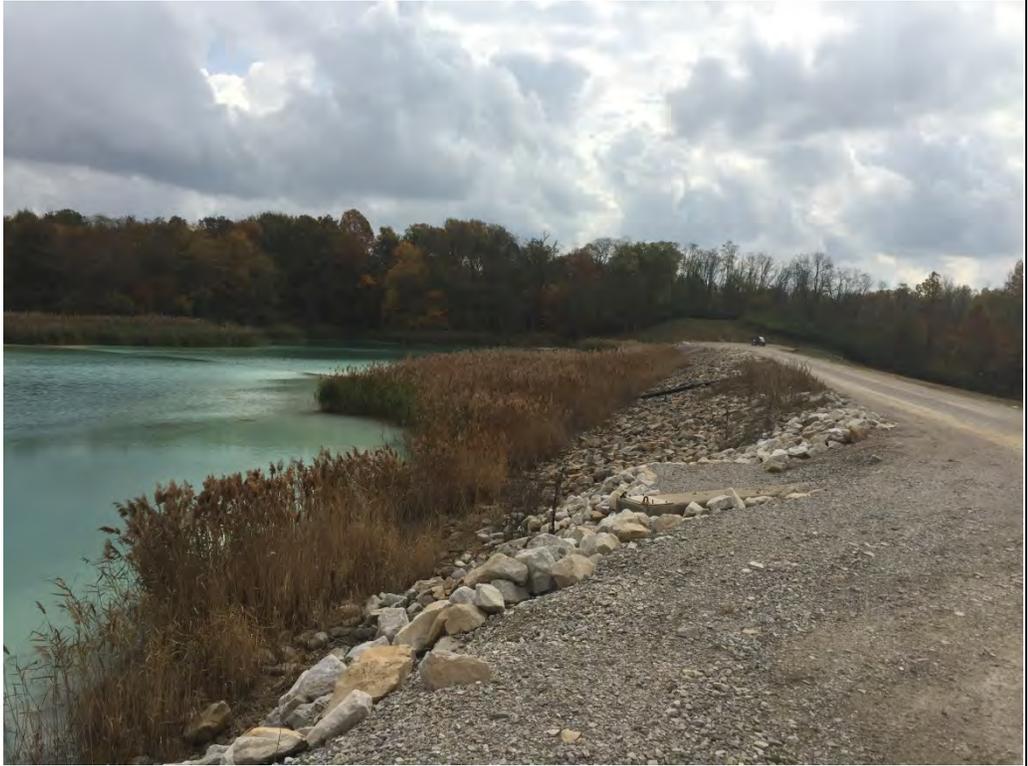
<p>Location: A.B. Brown Generating Station</p>		
<p>Description:          Standing midway along southern berm, looking back over surface impoundment.</p> <p>Picture shows stability of berm into surface impoundment.</p> <p>Photographer: Entwistle</p>

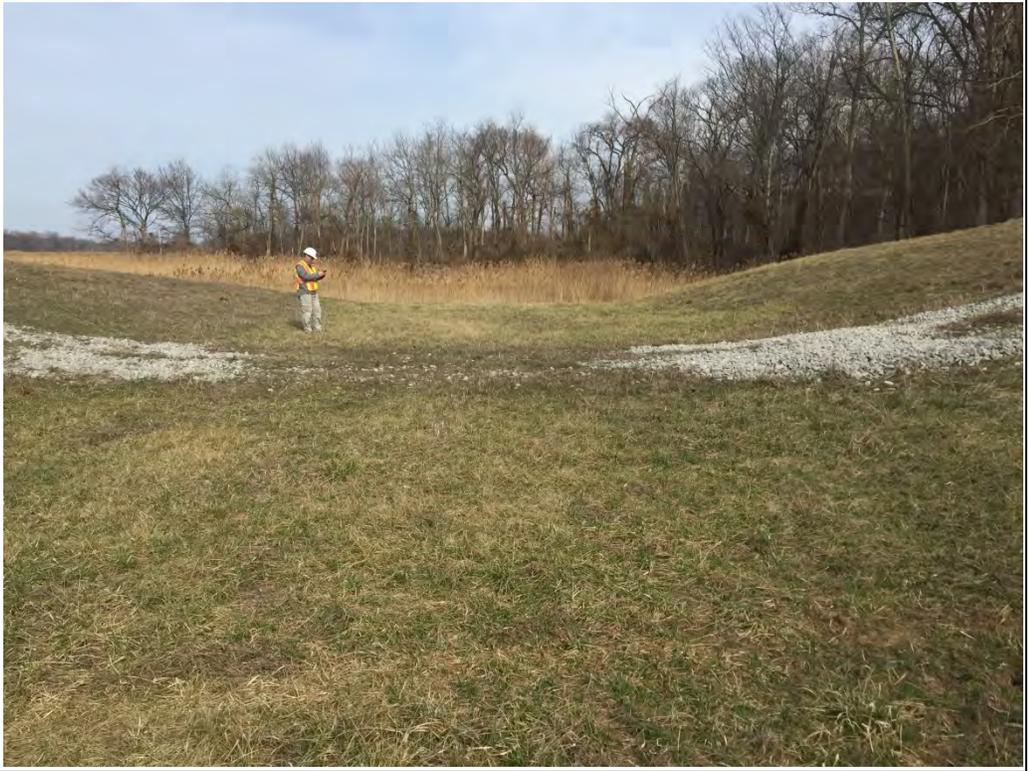
<p>Photo No. 5</p>	<p>Date: 02/23/2016</p>

<p>Location: A.B. Brown Generating Station</p>		
<p>Description: Standing in secondary emergency spillway looking downstream.</p> <p>Picture shows adequate slope protection and no evidence of erosion.</p> <p>Photographer: Entwistle</p>		
<p>Photo No. 6</p>	<p>Date: 02/23/2016</p>

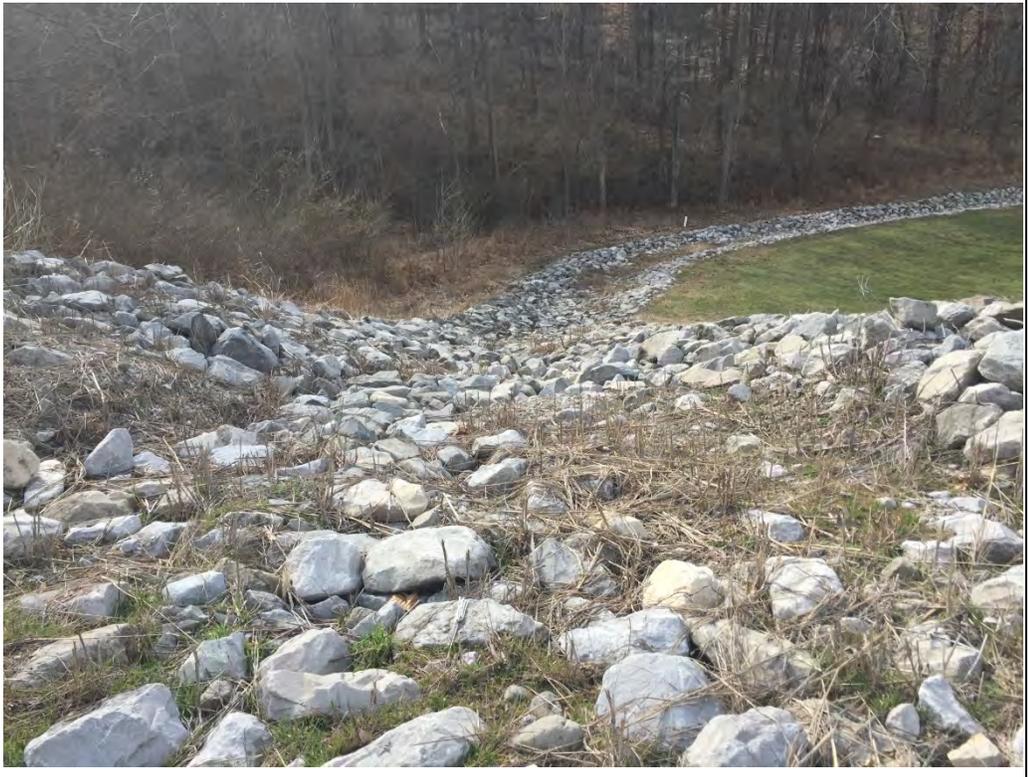
<p>Location: A.B. Brown Generating Station</p>		
<p>Description: Standing at top of secondary emergency spillway, showing riprap lining of discharge channel</p> <p>Picture shows adequate erosion protection.</p> <p>Photographer: Entwistle</p>

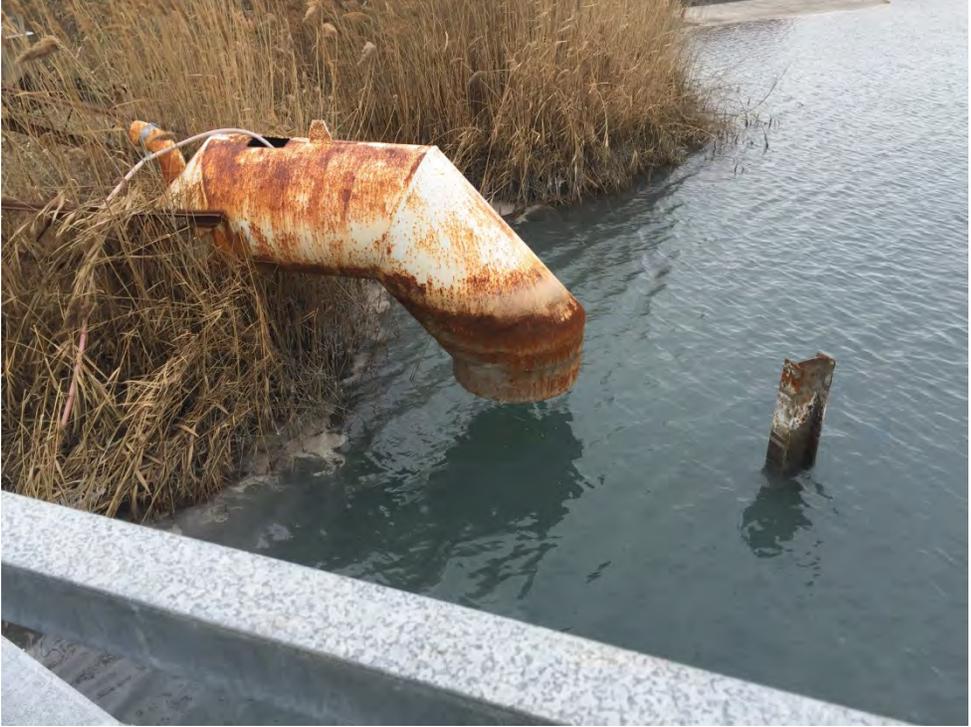
Photo No. 7	Date: 02/23/2016

Location: A.B. Brown Generating Station		
Description: Standing on the pumping station.  Picture shows inlet to gooseneck emergency overflow penetration into lower berm. Video of this structure provided separately.  Photographer: Entwistle

There is no current evidence of ash transport within the pipe and no noted signs of failure. However, since the pipe is a potential pathway for ash release from the impoundment, AECOM recommends a CCTV inspection of the Principal Spillway every other year, including the previous diversion conduit, as far as practical. Comparison of a current, bi-annual video to the baseline video established in 2014 provides for identification of potential changes in the pipe, joints, or staining which could be indicative of deterioration, deformation or distortion.
