July 19, 2017

CCR Annual Inspection

West Ash Pond

F. B. Culley Generating Station

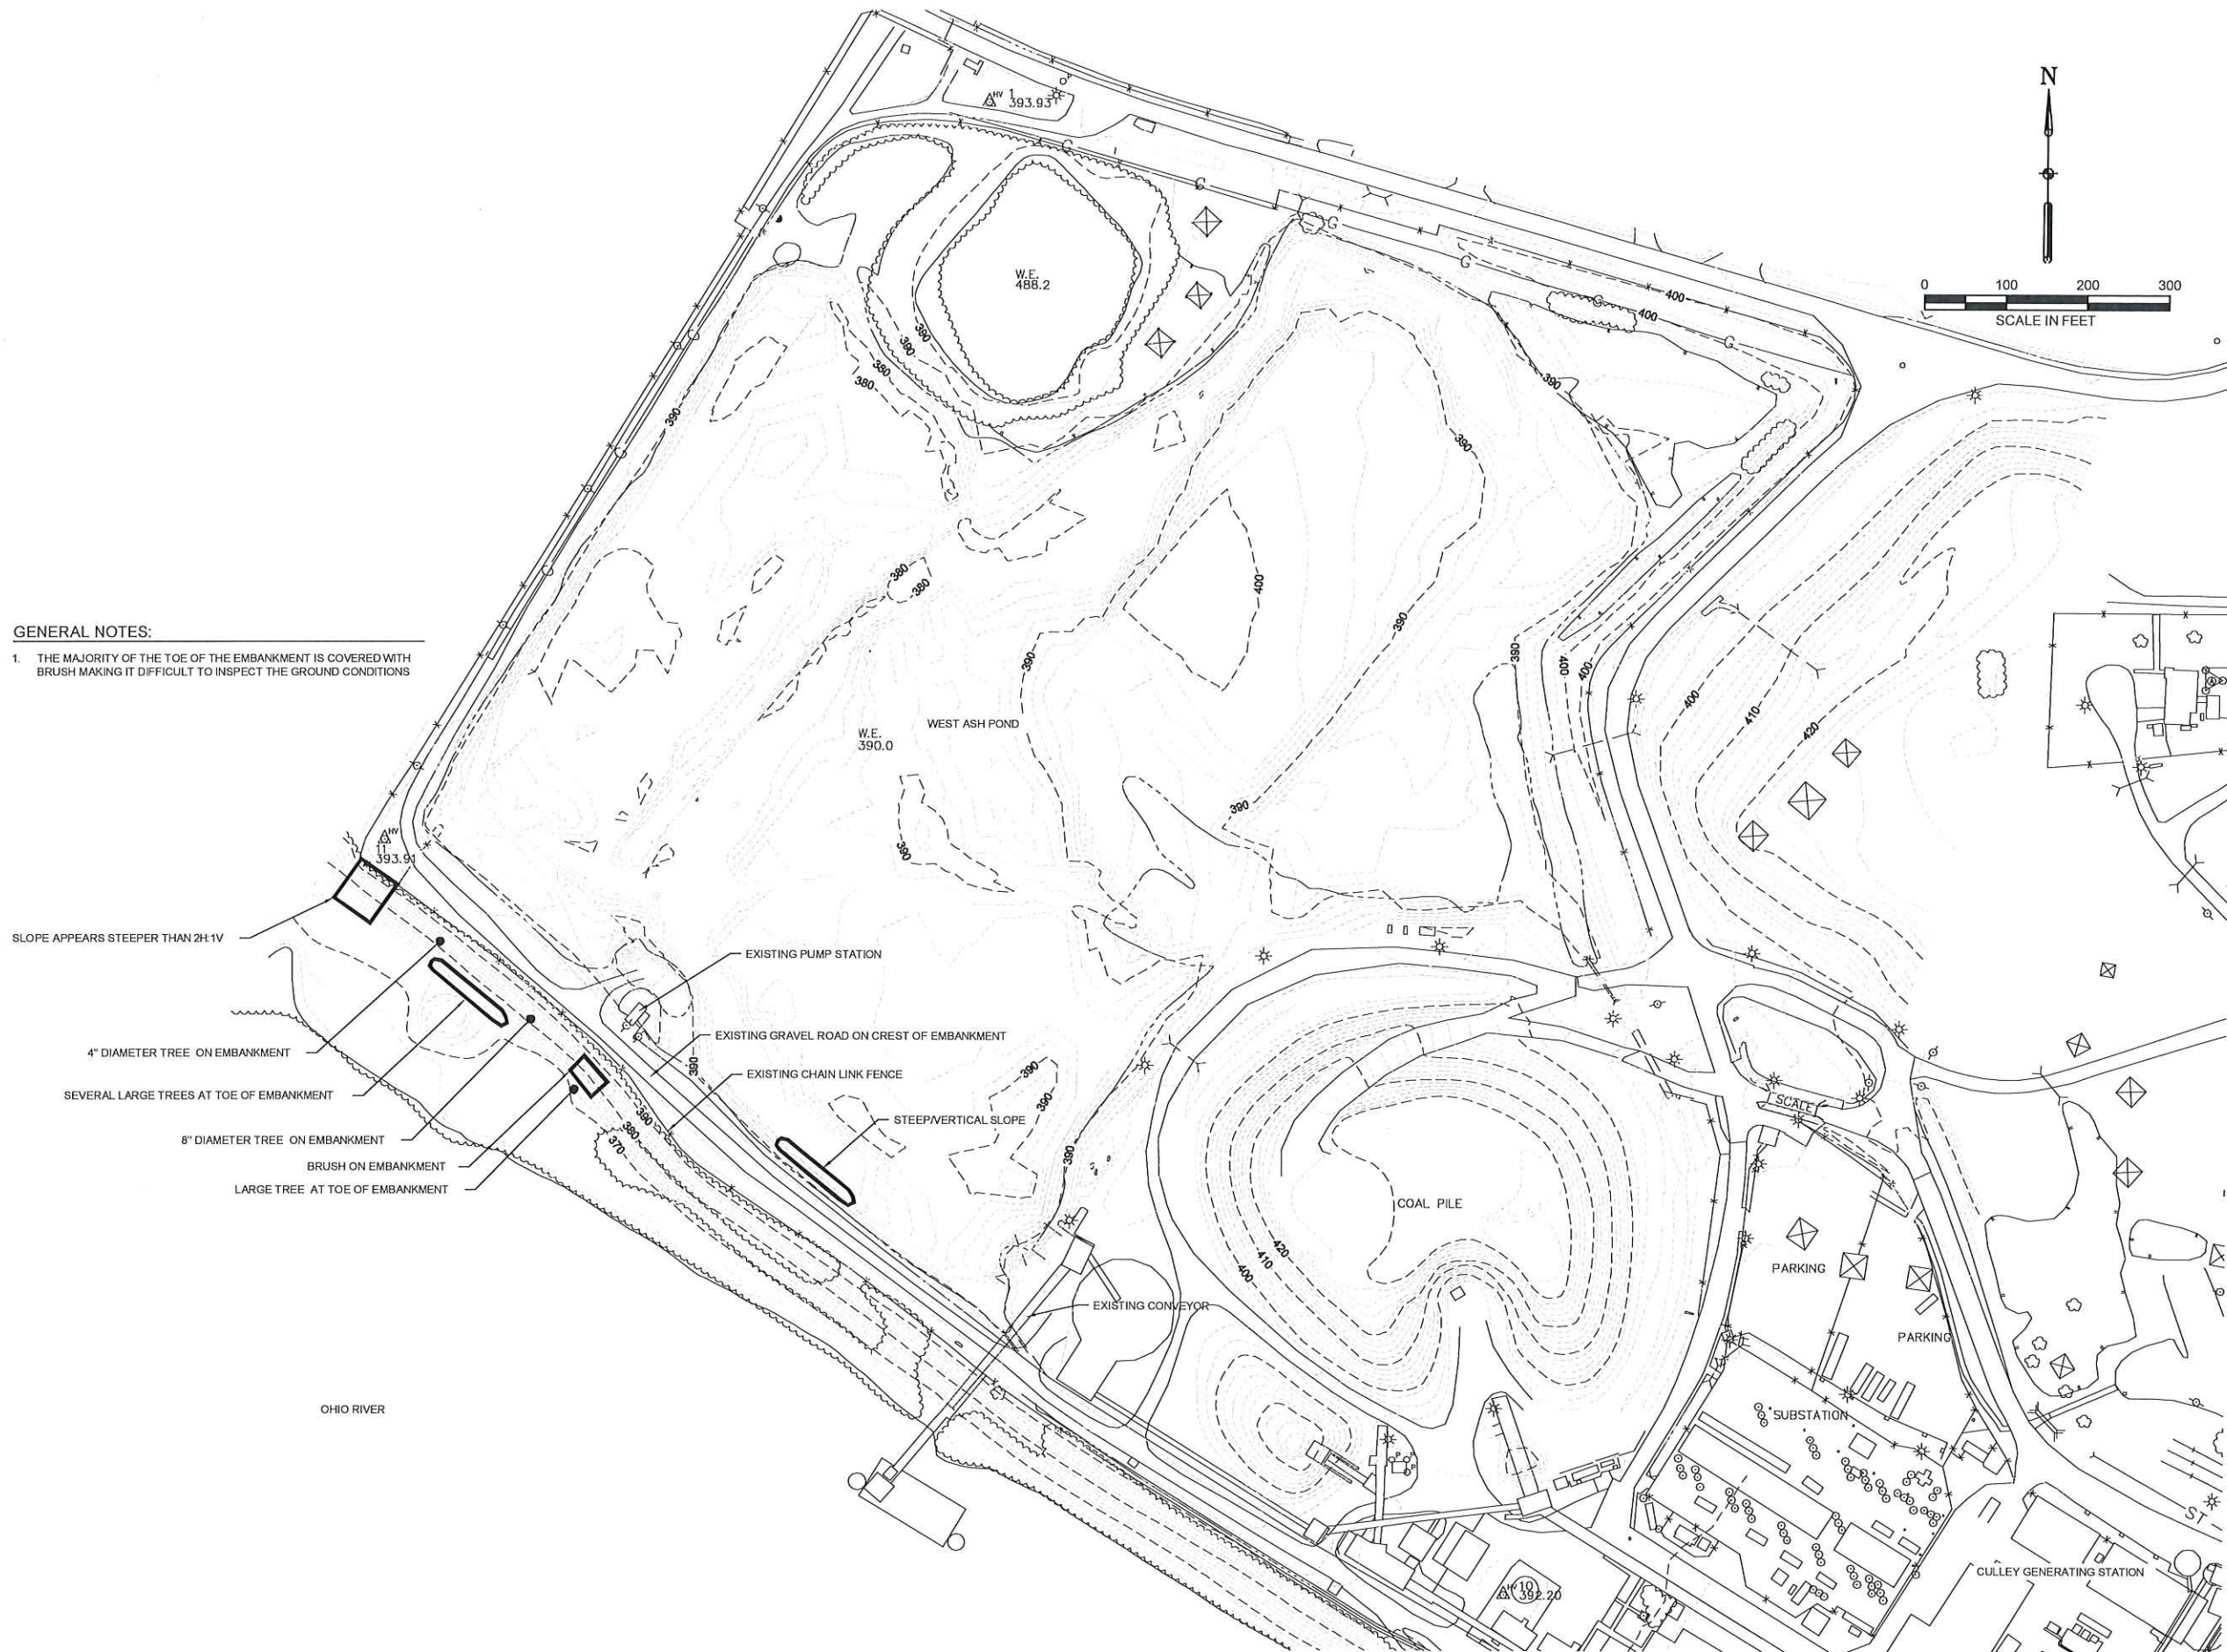
FIGURE 3

Table 2-3 – Areas of Concern (Current Inspection: June 20, 2017)	
Deficiency/Observation	Proposed Corrective Measure
Interior Slope – Near vertical side slopes are present where ash is collapsing into basin adjacent to access road.	Regrade to a suitable slope and install riprap cover.
Exterior Slope – A few small trees/bushes and brush have grown on the embankment slope.	Cut small trees/bushes to a level flush with the ground surface (so as to not disturb the subsurface) and spray remaining vegetation.
Toe of Embankment Slope – There are several large trees and overgrown brush at the toe of slope.	<p>The vegetation height requirement was remanded by the U.S. Court of Appeals on June 14, 2016. The downstream slope will be addressed once the replacement rule is issued by EPA and revised requirements are established.</p> <p>During the period from the initial annual inspection, an analysis was performed to determine the best management practice in regards to the referenced vegetation. The majority of the trees on the downstream slope of the embankment are at the toe and no seepage</p>

<p>was observed in this area. No visual evidence was observed of stability concerns (i.e., sloughing, depressions, erosion, etc.) Based on these observations and the size and extent of the trees, AECOM believes removing these trees at this time would result in significant disturbance to the unit, which could destabilize the embankment and could promote excessive erosion during high rainfall events. It is our opinion that the trees are currently necessary for stabilization of the embankment and are better left in place.</p> <p>Monitor brush and spray/remove if it continues to encroach onto embankment slope.</p>
--	---

- SLOPE APPEARS STEEPER THAN 2H:1V
- 4" DIAMETER TREE ON EMBANKMENT
- SEVERAL LARGE TREES AT TOE OF EMBANKMENT
- 8" DIAMETER TREE ON EMBANKMENT
- BRUSH ON EMBANKMENT
- LARGE TREE AT TOE OF EMBANKMENT

- EXISTING PUMP STATION
- EXISTING GRAVEL ROAD ON CREST OF EMBANKMENT
- EXISTING CHAIN LINK FENCE
- STEEP/VERTICAL SLOPE
- EXISTING CONVEYOR
